DOCK REPAIR

Sand Point Dock Inspection

Post-Seismic Event Evaluation

PND Engineers, Inc.
1506 West 36th Avenue
Anchorage, AK 99503

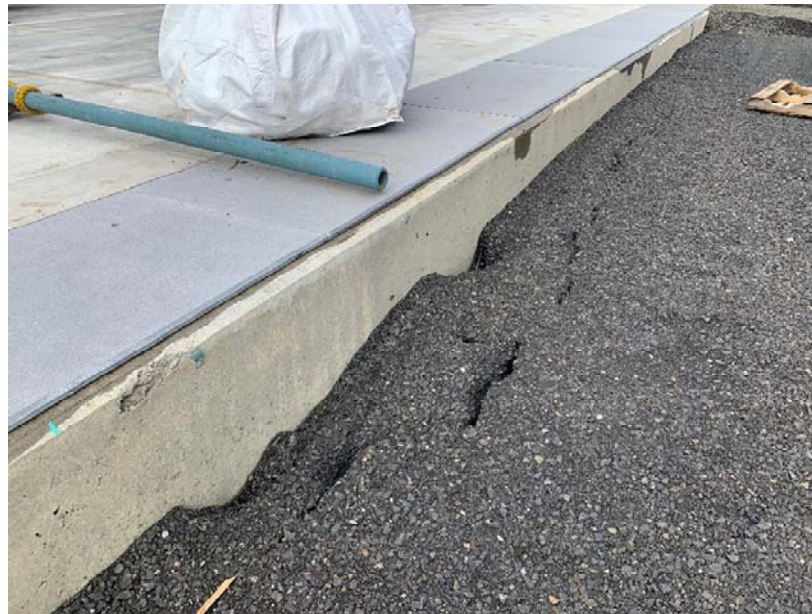
Figure 2: Fill settlement against abutment

The fill below the abutment and adjacent to the roadway settled during the earthquake approximately 8-inches to 12-inches. The settlement was most significant near the south end of the abutment, and decreases towards the north. To continue operations an earthen ramp was constructed to allow vehicular access, seen below in Figure 4:

ID	Dock	ID	Deficiency	Recommended Repair
1.1	New	Fill	Fill settlement	Flatten and proof roll surface. Place and compact fill in 6" lifts to match dock elevation.
1.2	New	Plastic Hinges	Cracks	Inject low viscosity epoxy in to any cracks to seal and protect the joint

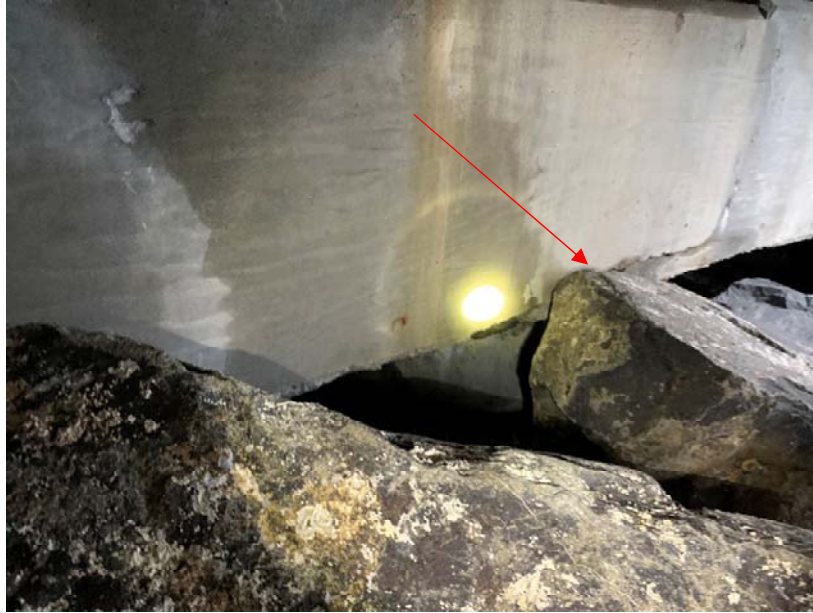
Figure 3: Abutment damage

The pile supported cast in place concrete abutment (Grid A) runs parallel the dock piers and provides a land-side landing for the deck panels. The abutment is approximately 6-feet wide and 4-feet tall. The abutment appears to have sustained a small amount of damage at the south end due to a falling piece of rip-rap striking lower-ocean side corner near Grid A-1. The damage can be classified as superficial, as shown below in Figure 3:

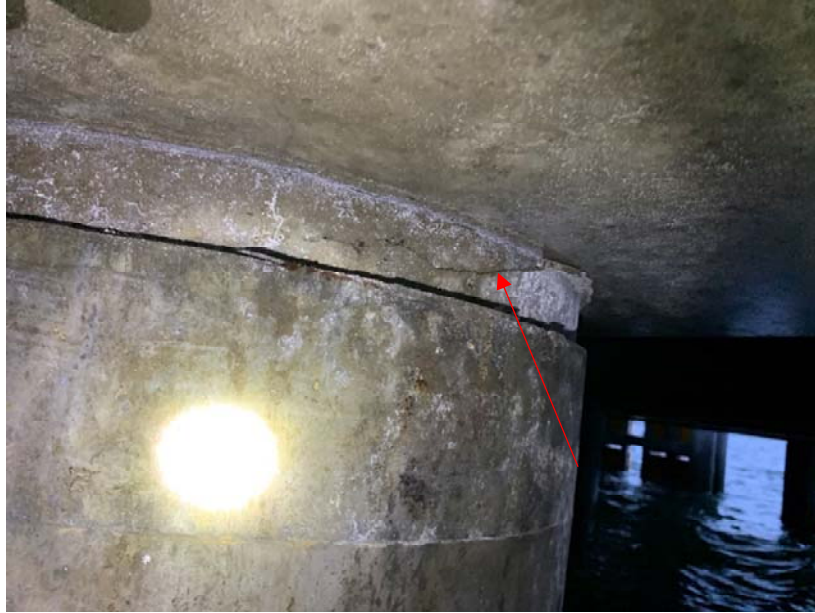
Figure 5: Cracking at Pile B9

Pile ID	Description of Plastic Hinge Damage
B5	Moderate spalling on south side
B6	Minor cracking near patch on north side
B7	Moderate spalling on east side
B9	Crack on north side
C2	Split at construction joint on west side
C3	Spalling on east side
C4	Spalling on south and east side
C9	Spalling on south and east side
D2	Spalling on east side
D6	Spalling on east side
D7	Spalling and possible cracking on east side
D10	Spalling and cracking on south and east side

The most significant crack was found on Pile B9, and can be seen below in Figure 5:

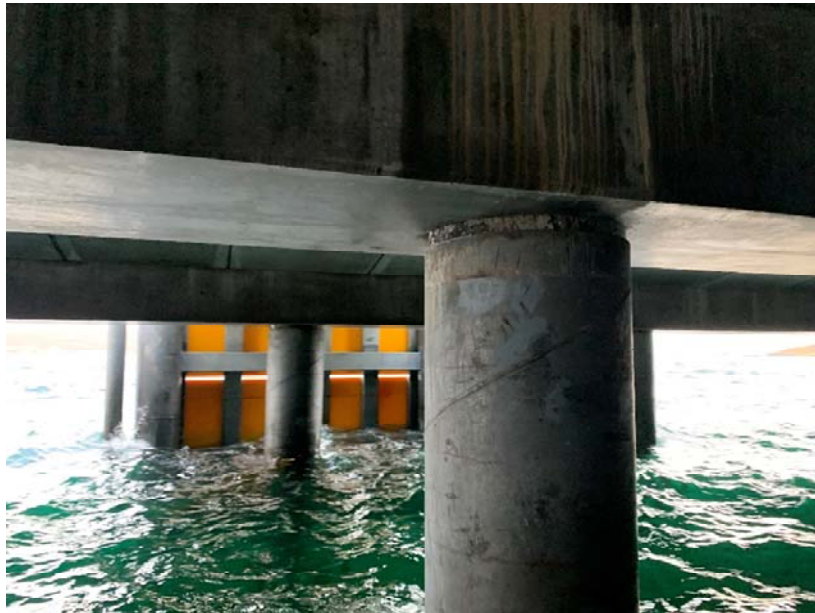
Figure 6: Typical notable spalling at plastic hinge, Pile C4

Typical notable spalling can be seen below in Figure 6 at pile C4:

1.3	New	Plastic Hinges	Spalling	Remove surface concrete and trowel pack a repair mortar/grout and/or apply low viscosity epoxy
1.4	New	Grout Joints	Cracks located in panel joints	Seal cracks using approved low viscosity concrete sealant (i.e. Sikadur) per manufacturer recommendations.

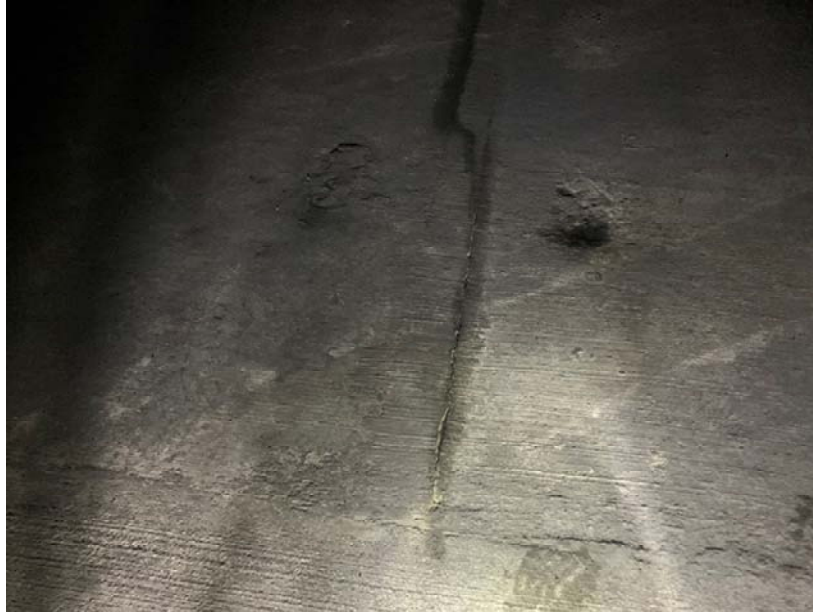
Figure 7: Typical topside grout line cracking

There were no noted deficiencies, cracking or damage on the deck panels themselves, though it does appear that there are locations on the south half of the dock where the grouted joints cracked and are allowing water to penetrate from the deck through to the bottom side of the panel, shown below in Figures 7 and 8.

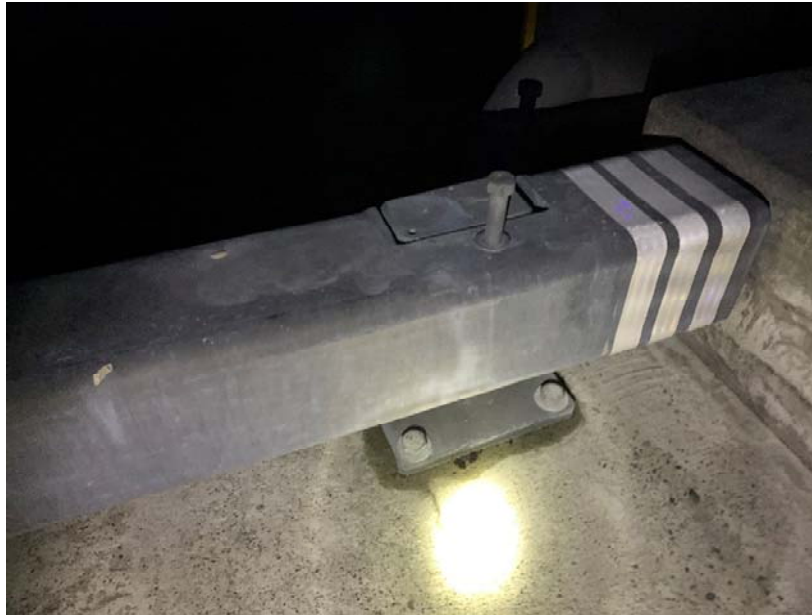
Figure 11: Disengaged bolt in bullrail near gridline D3.5

The bullrails had one noted deficiency, the bolted connection near gridline D3.5 was found to be loose and not engaged with the nut below. Upon removing the bolt it appeared that the through holes in the bullrail were not lined up with the nut below.

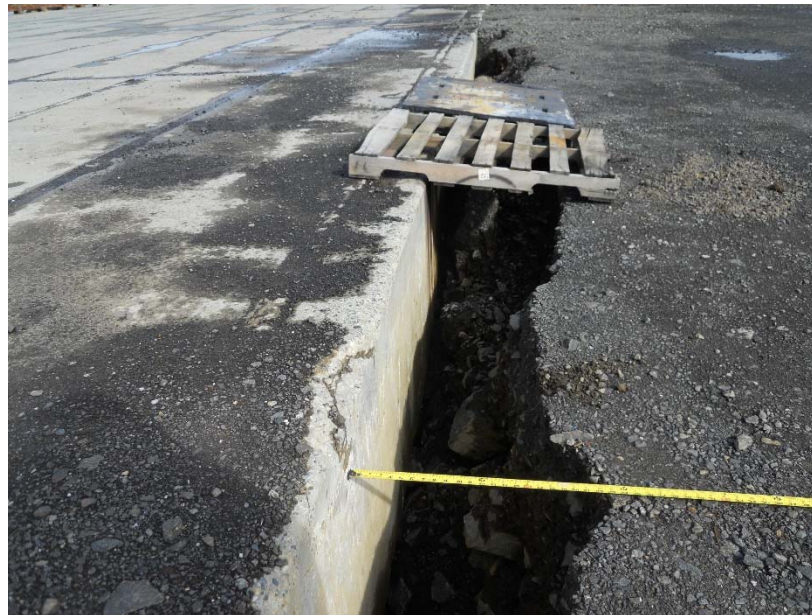
Figure 13: Fill settlement/separation

The concrete perimeter cast in place vertical abutment was visually inspected and did not appear to have any significant damage. The adjacent fill however has settled between 8-inches and 12-inches vertically, varying in severity along the dock face. This settlement caused fill to fall below the backwall, and has created a void between the fill and decking that varies in severity from no horizontal gap to as much as a 3-foot opening. A gravel access ramp has been pushed up on the north end of the dock for access and several pallets were bridged for access on the south end.

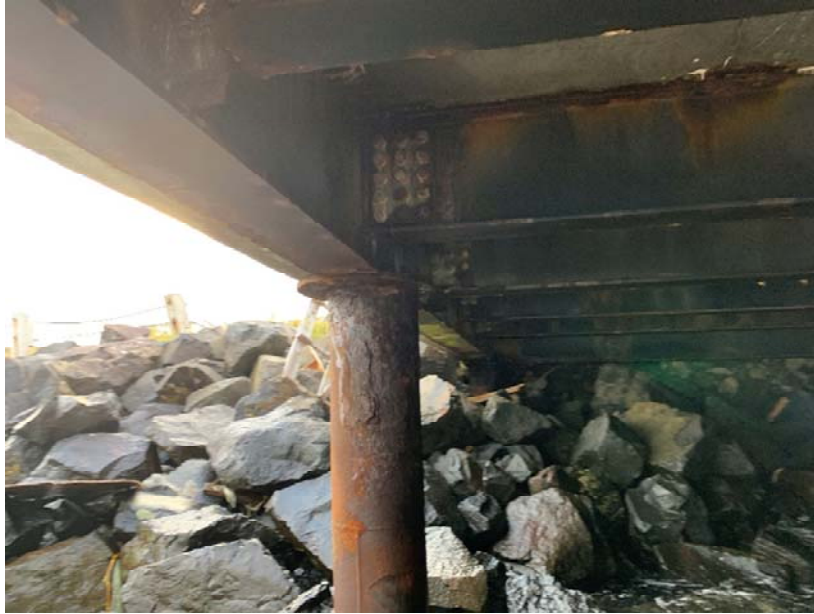
Figure 14: Typical pile condition, Pile B1

The steel piling on grid line A was inspected by foot at low tide while the remaining piling on grid lines B-D were inspected by skiff during the on-water portion of the inspection. All piling appeared to be heavily corroded near the cap plates, but in most cases appeared in serviceable condition with the welds to the superstructure in-tact.

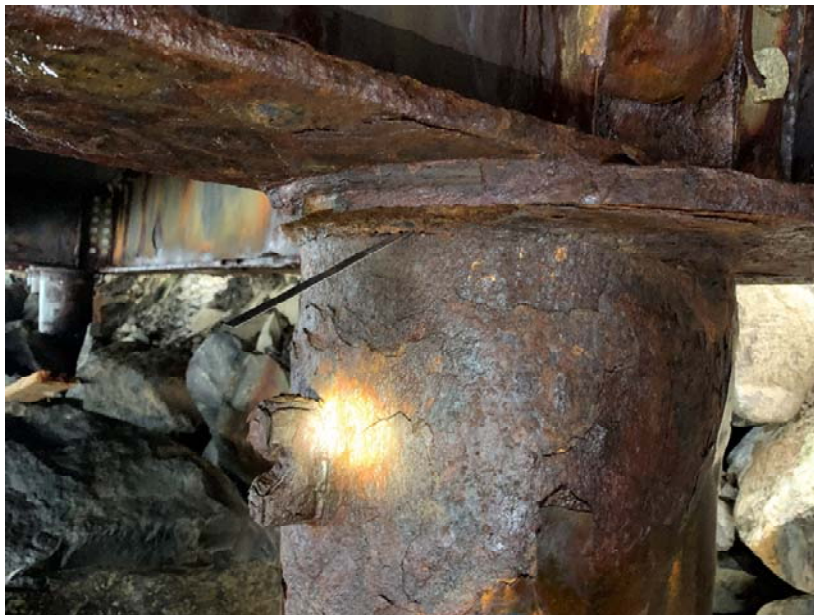
Figure 15: Weld Interface crack at Pile A6

Notable damage in the form of cracking was found at or near the pipe-weld interface on Piles A3, A6 and A7. Two of the cracks (piles A6 and A7) were only a few inches in length and were so small only a 0.02-inch thick metal scale could be inserted. See photos below in Figures 15 and 16:

2.2	Old	Piling	Weld-pile interface cracks at pile A3, A6 and A7	Grind and remove crack to root, perform NDT to ensure full removal of crack, reweld the connection, and perform NDT to verify the competency of the repair.

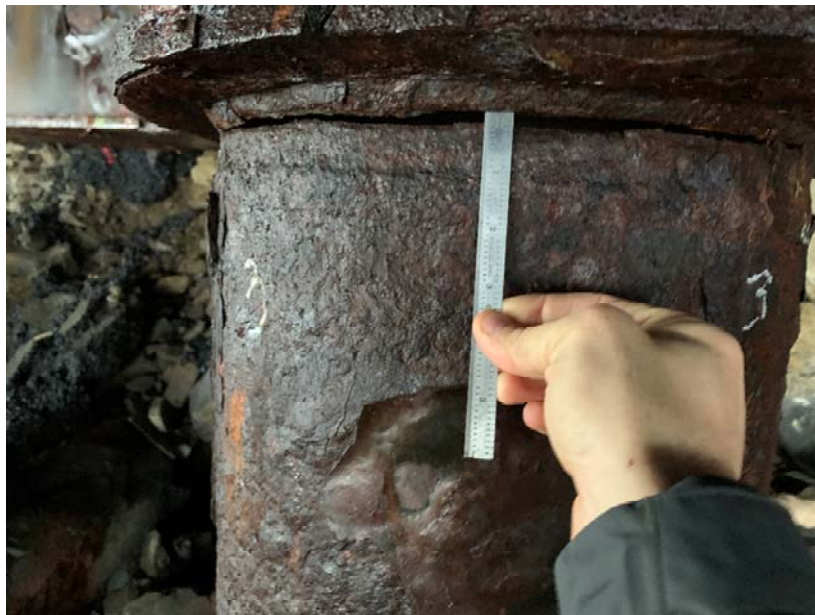
Figure 17: Weld interface crack at Pile A3

The crack in Pile A3 was significant, with the largest opening being approximately 1/4" and slightly over 1/3 the diameter of the pile. Photos of Pile A3 can be seen below in Figure 17:

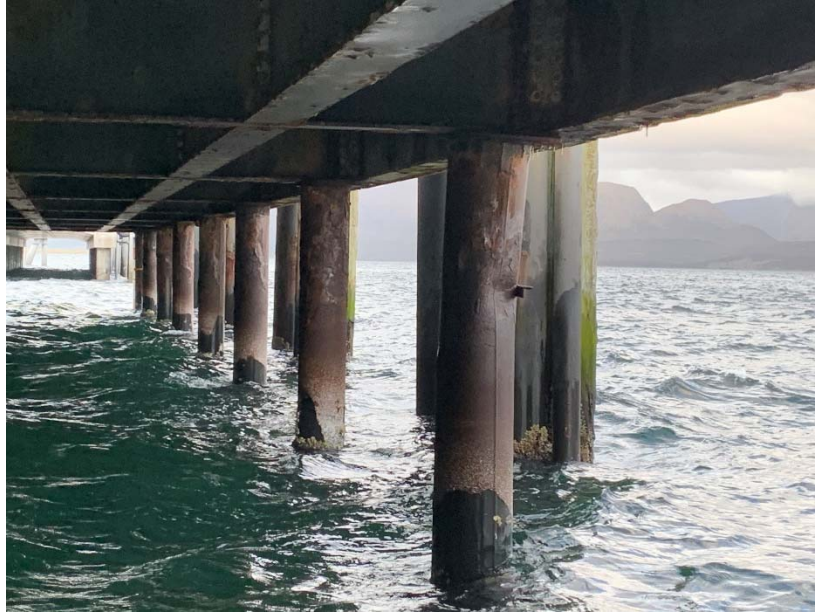
Figure 18: Impact Damage to Pile D3

Pile D3 appears to have sustained impact damage approximately 3' below the cap plate, as seen below in Figure 18:

2.3	Old	Piling	Piling D3 impact damage	Install a welded cover plate over the impacted area.
2.4	Old	Steel components (general)	Severe corrosion	Remove corrosion and address with new coating and additional cathodic protection per 2016 PND/Taku Engineering condition assessment

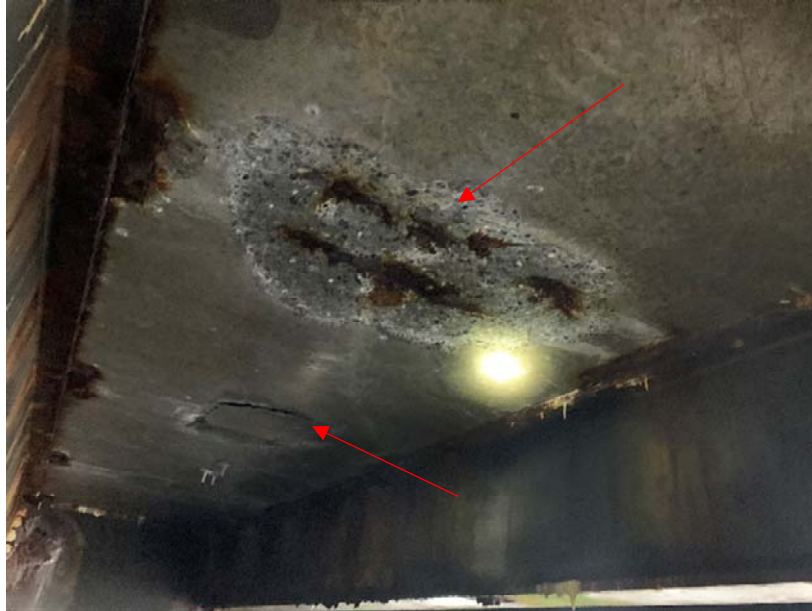
Figure 20: Fully spalled and nearly spalled sections

The bottom side inspection revealed consistent deep spalling of the panels between Grid Lines A and B, most frequently in the first two secondary framing bays. In a number of locations, the spalling has exposed the bottom layer of rebar, which had observable corrosion. In the second and third secondary framing bays there are also a number of locations where spalling was observed, but the spall had not fully detached from the concrete. See examples of both in Figure 20, located in Bay 2, between rows 4 and 5 and rows A and B:

2.5	Old	Deck Panels	Approximately 11 of the deck panels in the first two bays have significant spalling on the bottom face.	Saw cut and remove surface concrete from all spalled sections. Clean rebar and apply an epoxy sealant. Surface pack repair grout/mortar to the bottom of deck panel.

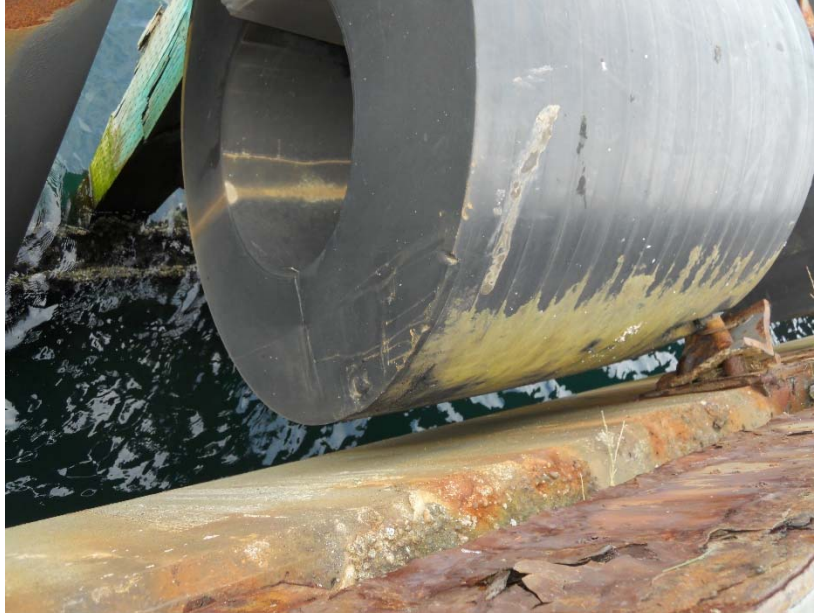
Figure 21: Fender disconnected from dock

The dock face fenders are comprised of driven pipe piling, energy absorbing rubber elements, and timber wear facing. The upper elements were inspected by foot from the topside, and substructure inspected by skiff during the on-water portion of the inspection. The fenders are in poor condition, with a number of timbers missing, partly disconnected, or broken. The brackets attaching the rubber energy absorbers to the dock were broken on the center fender (near grid D5) and the fender is now detached from the dock. The disconnected fender can be seen in Figure 21 and the damaged/missing timbers can be seen in Figure 22:

2.6	Old	Fenders	Fender D5 is disconnected from dock. Fender timber wear facing is damaged, dislodged or missing, typ. all fenders.	Recommend installing a new, modern fender system. It is PND's experience that retrofitting fender systems can become complex and expensive. Full replacement of fender system is a more cost-effective long-term solution.

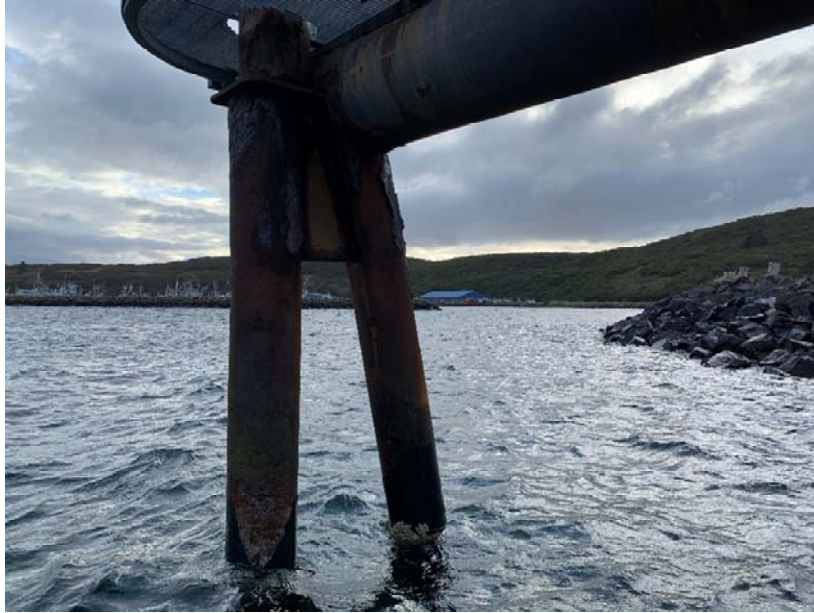
Figure 23: Damaged batter pile

The dolphin to the north of the old dock was inspected by foot from the topside and the substructure by skiff. The superstructure was free of deficiencies and in fair condition. It appears that the dolphin has been impacted, as the stiffener plate in between the vertical and batter piles has caused an indent and some apparent buckling on the batter pile, see below in Figure 23:

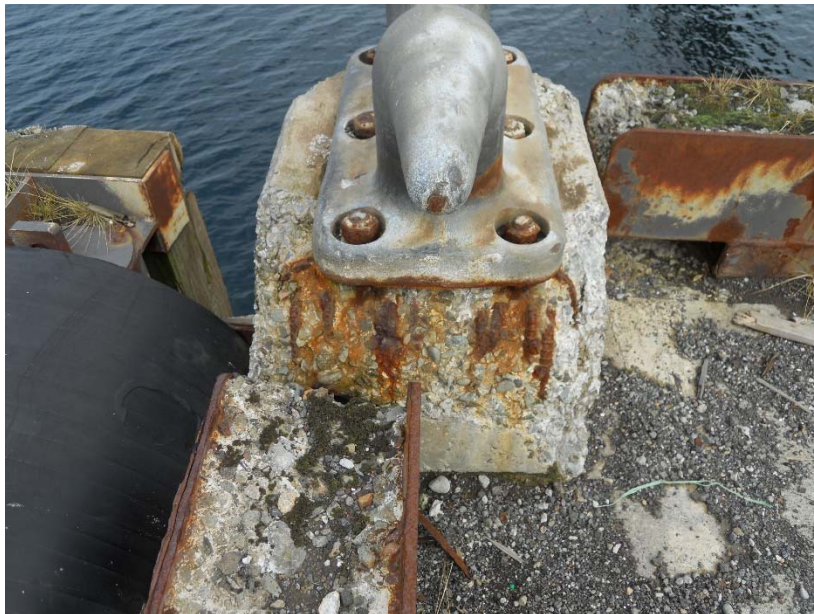
Figure 24: Bollard D1

There are seven mooring bollards on the old dock, the two southernmost were rehabilitated during the construction of the new dock. The bollards at Grid D1 and A1 are significantly spalled and the bases should be repaired. The remaining bollards are in serviceable condition. Bollards D1 and A1 can be seen in Figures 24 and 25:

2.7	Old	Mooring Bollards (A1 and D1)	Concrete bases have significant spalling exposing reinforcement	Remove bollards from bases, demo bases, reinstall new reinforced concrete bases, reinstall mooring bollards

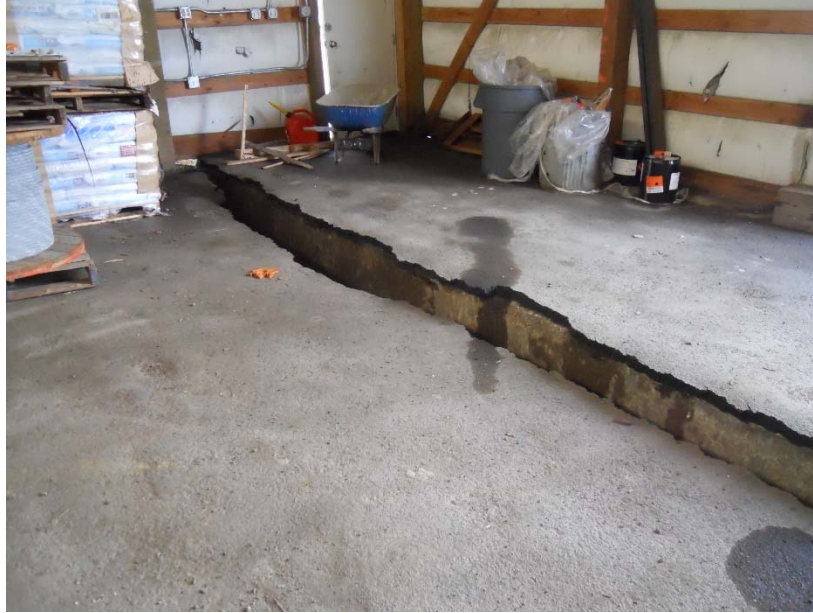
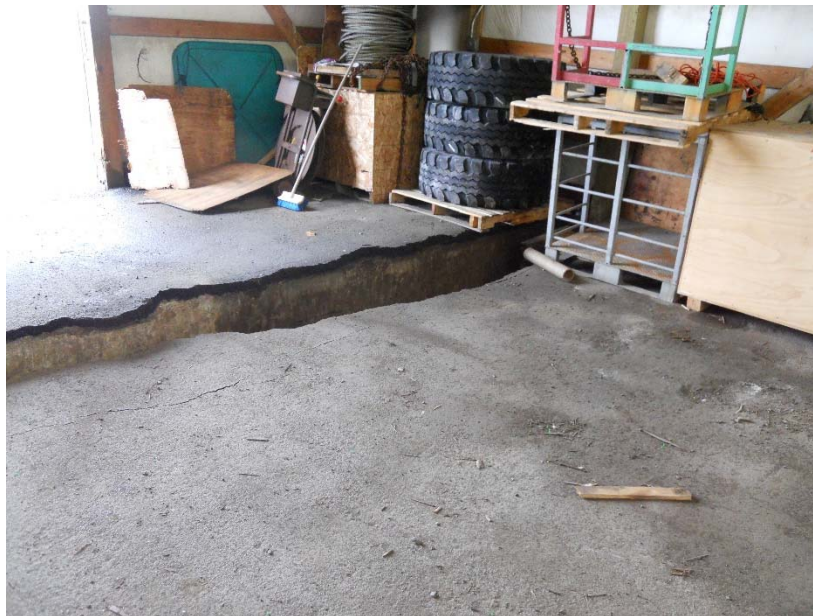
on the adjacent fill. There is 2" of asphalt surfacing installed inside the shop, including the area covering the concrete deck panels. Seismic induced settlement caused a shear failure in the pavement, and the landward side settled 8 to 10-inches vertically and 12-inches to 20-inches horizontally landward. Photos of the settlement can be seen below in Figures 26 and 27:

Figure 26: Metal building floor settlement

Figure 27: Metal building floor settlement

2.8	Old	Metal Building	Earthquake damage to metal building asphalt surface and minor exterior damage	<p>If reusing building is desired: remove existing building by disassembling most components that could be reused. Replace earthquake damaged components (buckled wall, roof edging). Remove asphalt, proof roll and fill and compact in 6" lifts to bring back to dock elevation. Repave and reinstall building.</p> <p>If new building is desired: demo existing building, install new building on concrete foundation.</p>
-----	-----	----------------	---	---

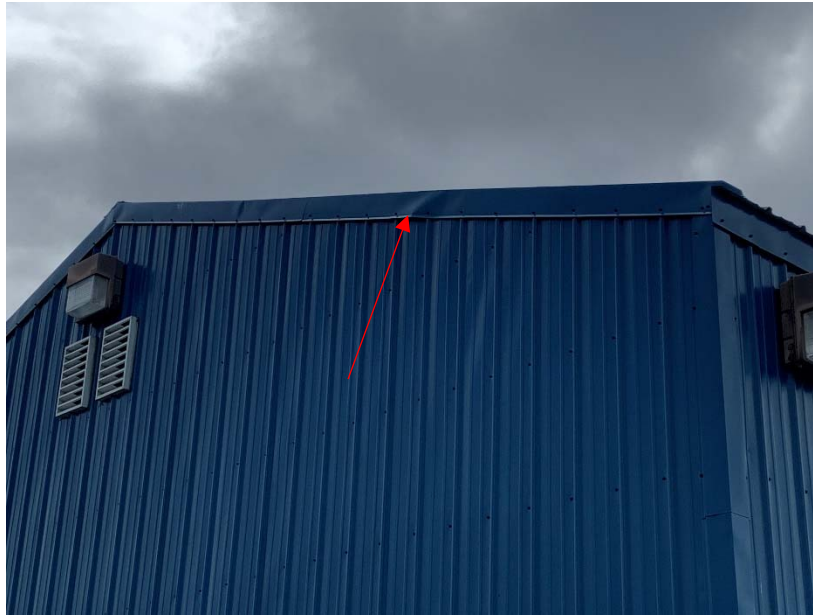
The metal building sustained little damage due to the pole barn construction style of the supporting framing and flexible nature of the structure. Isolated damage to the metal roofing was observed at the dock-fill interface where the settlement occurred (Figure 28). Out-of-plane buckling in the metal siding and trim on the shear wall on the landward side of the building was also observed (Figure 29). The doorways were also racked with the doors unable to close fully. Overall, due to the flexible nature of the

Figure 28: Roofline damage (typ north and south sides, same location)

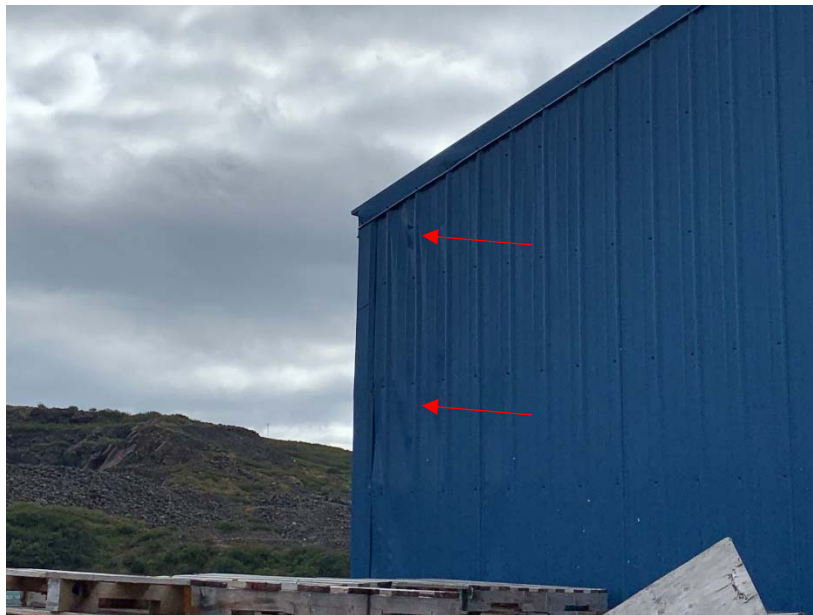
Figure 29: Out-of-plane shear buckling (typ north and south ends, same location)
