DOCK REPAIR

Sand Point Dock Inspection

Post-Seismic Event Evaluation

PND Engineers, Inc.
1506 West 36th Avenue
Anchorage, AK 99503

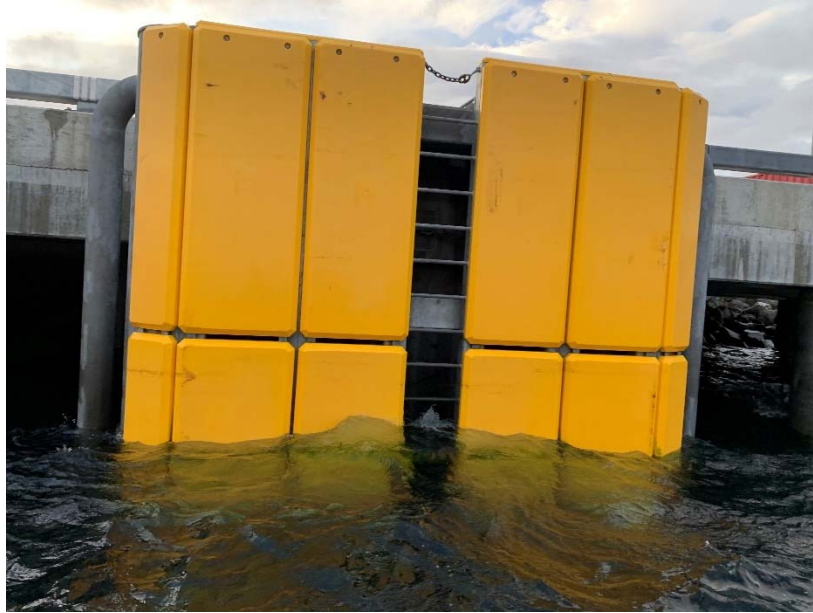
Figure 9: Fender Face

The dock face fenders are comprised of driven pipe piling, energy absorbing rubber elements, and plastic wear facing (see Figure 9). The upper elements were inspected by foot from the topside, and substructure inspected by skiff during the on-water portion of the inspection. No deficiencies were noted.

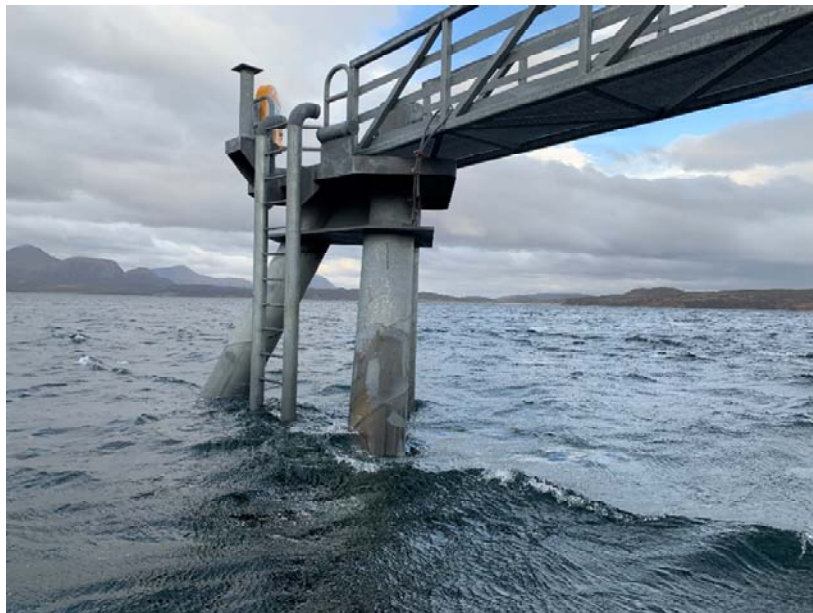
Figure 10: South Dolphin

The dolphins had no noted deficiencies (see Figure 10).

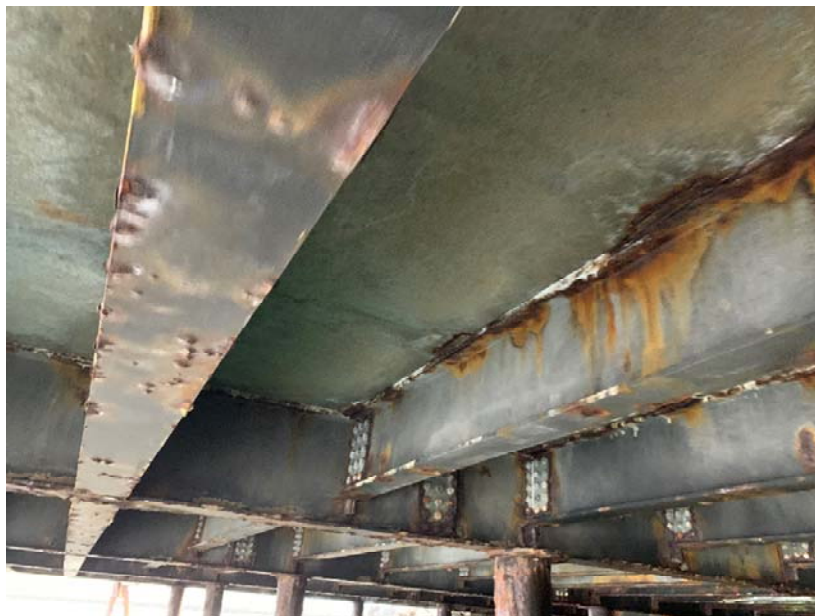
Figure 19: Typical Dock Framing

Steel framing was inspected below the dock both by foot and skiff. Due to swells and wind, inspection duration was brief, but connections were verified to have all bolts and girders were inspected for any apparent damage. No bottom flange or web cracking or deformities were noted.
